Subj: HARIO CHILD DEVELOPMENT CENTER (BUILDING 5140) DRINKING WATER

Overview of Testing Results for Lead in Drinking Water and Corrective Actions for CFAS Hario CDC (Building 5140)

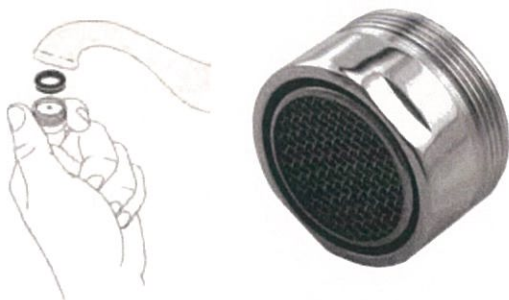
Four of the six faucets that exceeded 15 ppb were two outdoor bubblers outside of room 110 (20 ppb and 26 ppb), an outdoor hose faucet outside of room 126 (55 ppb), and an outdoor playground faucet outside of room 129 (17 ppb). Follow-up sampling at these outlets was conducted after removing and cleaning the faucets, faucet aerators and hose bibb vacuum breakers. For example, a faucet aerator (or tap aerator) is often found at the tip of modern indoor water faucets. Without an aerator, water usually flows out of a faucet as one big stream. An aerator spreads this stream into many little droplets, which helps save water, provides more uniform flow, and reduces splashing. However, the aerator and screen can trap debris which can accumulate lead. A hose bibb vacuum breaker is attached to hose faucets to prevent backflow or back-siphonage into the water system.

After removing and cleaning the faucets, aerators and hose bibb vacuum breakers, retesting showed that these faucets were below the screening level. The installation is implementing a periodic aerator maintenance plan to sustain this corrective action.

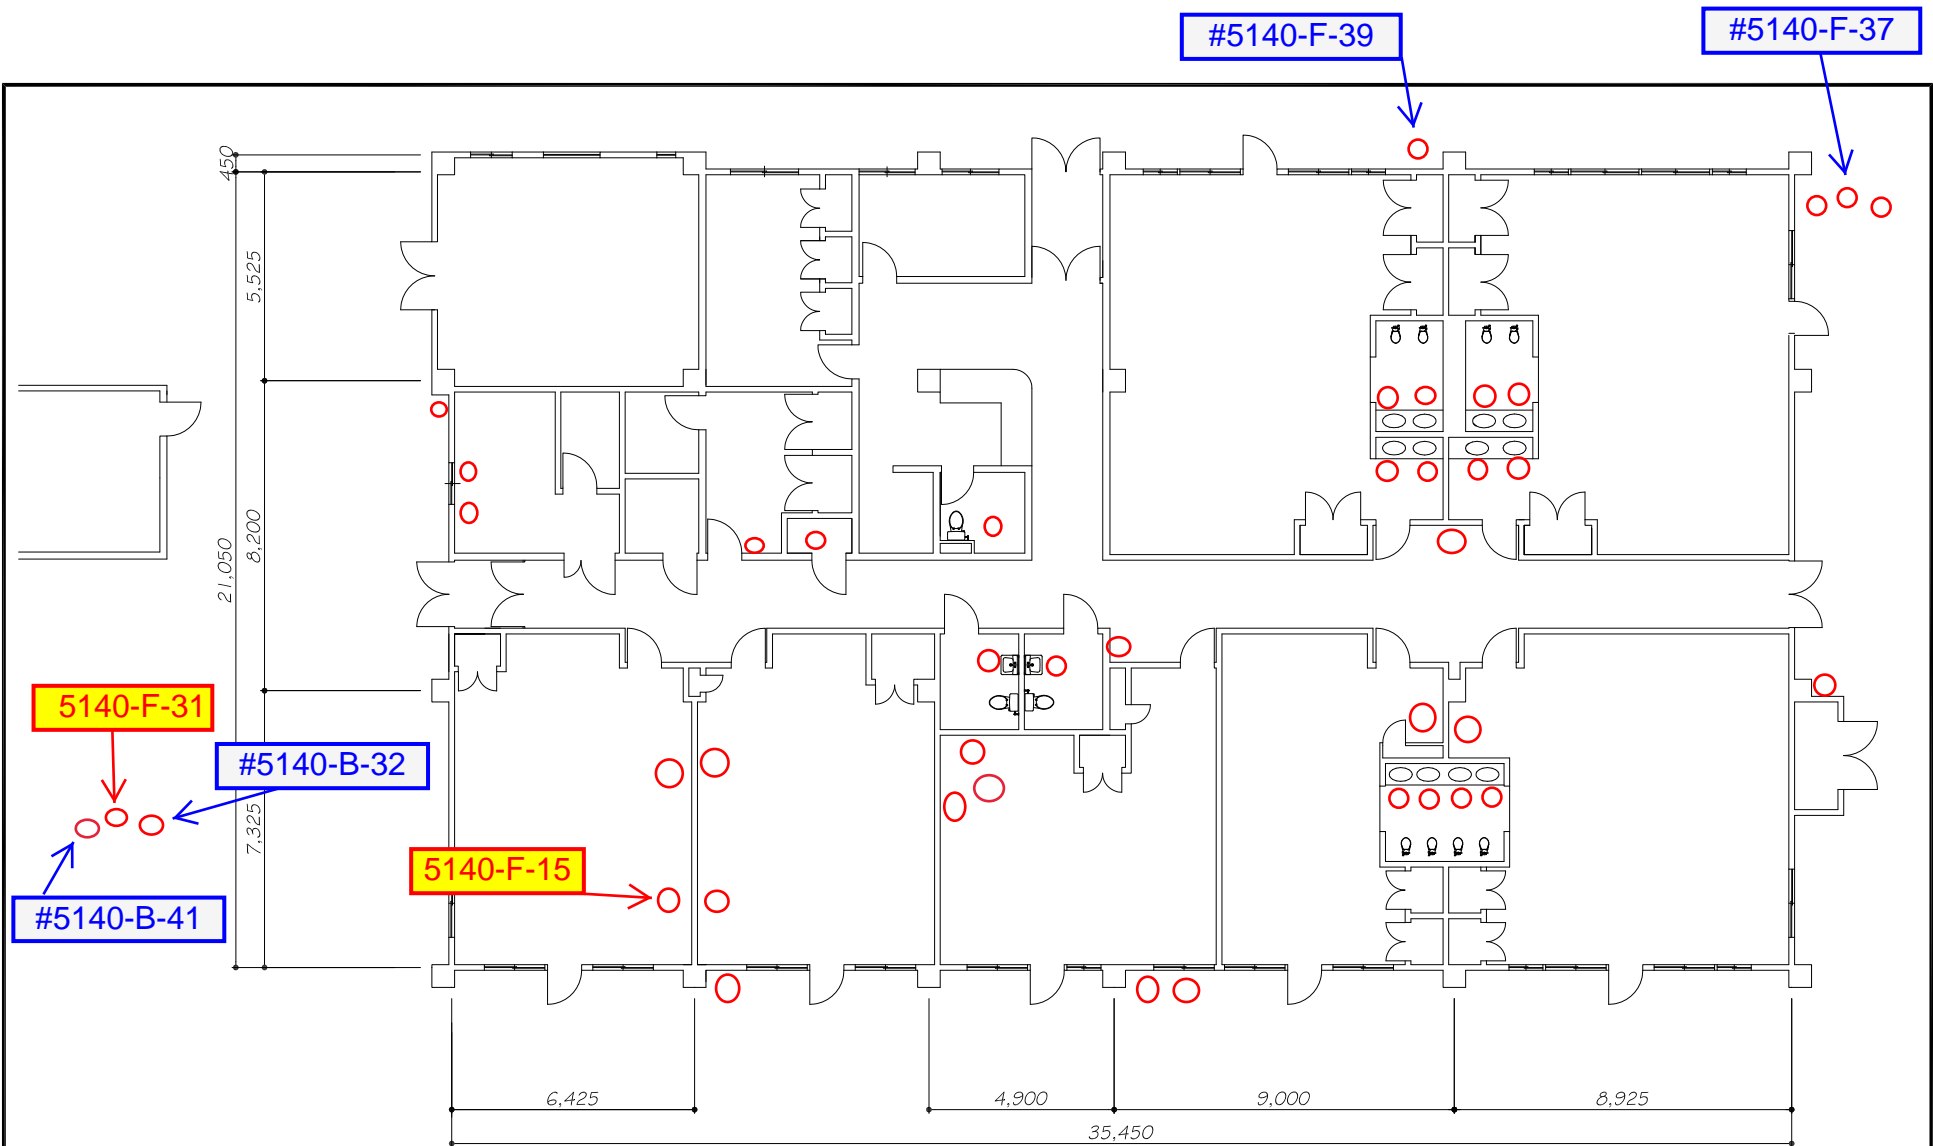
FLOOR PLAN : BLDG.#5140, CDC

The remaining two of the six outlets that initially exceeded the screening level of 15 ppb were a sink faucet in the Infant Room 110 and an outdoor hose faucet outside of Room 110, which tested at 46 ppb and 27 ppb, respectively. Since follow-up resampling indicated that the elevated

A floor plan of the Hario CDC has also been included to show the locations for the fixtures that exceeded 15 ppb.

levels of lead appeared to be caused by the components of the fixtures, these faucets were shut down from use. New faucets have been installed. Testing conducted after implementation of these corrective measures shows that these faucets are now below the screening level of 15 ppb.
