Subi: MORALE, WELFARE, RECREATION GYMS AND FACILITIES DRINKING

Overview of Testing Results for Lead in Drinking Water and Corrective Actions for U.S. Naval Air Facility Atsugi (NAFA), Morale, Welfare, Recreation (MWR) Gyms (Building 3076 Picnic Area 1A)

Lead in Priority Areas (LIPA) and Corrective Actions NAFA Morale Welfare Recreation (MWR) Bldg. 3076 Picnic Area 1A

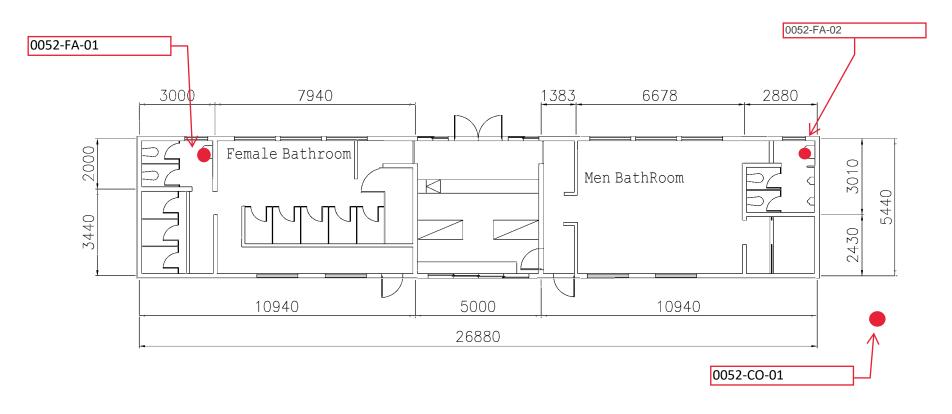
Outdoor Pool LIPA 2024

| | D " | | | | Sampling | 5 | Results | Screening | |
|---|---|---|---|---|---|---|---|---|--|
| Outside | N/A | Cooler | 0052-0003-CO-01 | 24-Jul-24 | 6:01 | H.Namiki | N.D. | 0.010 | |

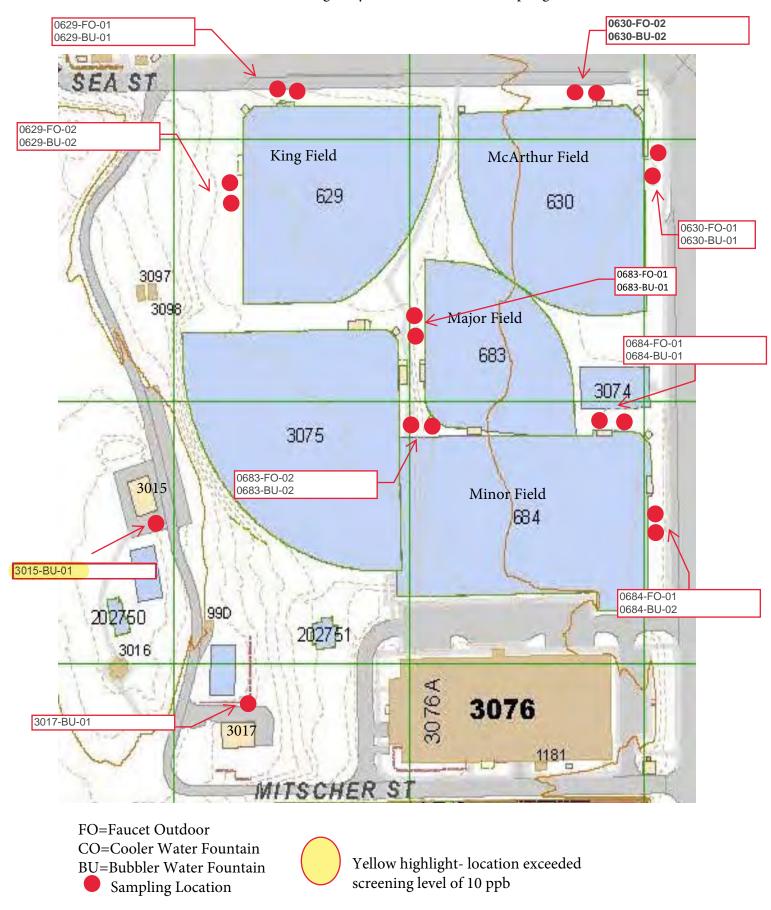
B3076 Ranger Gym Outdoor Fields (Sampling Floor Plan)

At the MWR gyms and facilities, outlets used for drinking, cooking, and washing were tested. Out of 51 samples collected, one (1) water bubbler initially tested above the Navy screening level of 10 parts per billion (ppb) for lead in drinking water in building 3076 Picnic Area 1A. The outlet was secured and temporarily removed from service.

| | | 0.4.5 | a | | Sampling | 5 | Results | Screening |
|---|---|---|---|---|---|---|---|---|
| Picnic Area - 1A | N/A | Bubbler | 3076-3015-BU-01 | 24-Jul-24 | 6:38 | H.Namiki | 0.017 | 0.010 |

In accordance with Commander, Navy Installations Command (CNIC) Instruction 5090.6A, the affected bubbler was flushed and resampled. Follow-up confirmation sampling indicates that the lead concentration in the water from this bubbler is below the screening level after flushing, and therefore the bubbler will return back to service. A flushing program will be implemented in an effort to prevent potential lead leaching into the water.

| | | IG LOCATION DESCRIPTION | | INITIAL SAMPLING RESULTS | | | R | E-SAMPLING RESUL | .TS | CORRECTIVE ACTIONS | |
|---|---|--|---|---|---|--|--|---|--|--|--|
| DRINKING | 3076-3015-BU- 01 | Building 3076 Ranger Gym, Picnic Area 1A, Bubbler | Bubbler | 17 | YES | 8/21/2024 | N/A | 9.9 | 1.6 | Follow-up testing was conducted after flushing occurred at the bubbler with lead levels higher screening level. Since the follow-up results showed levels below screening level, bubbler will return back to service. A flushing program will be implemented in an effort to prevent potential lead leaching into the water. | |

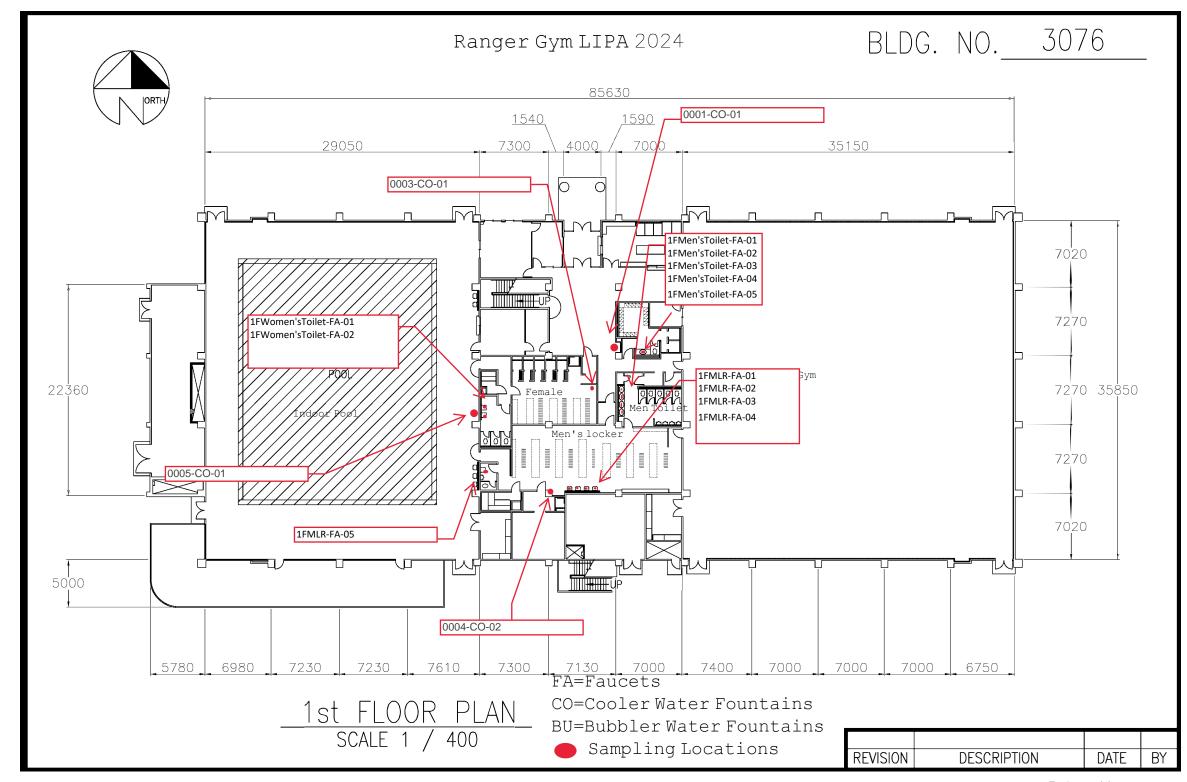
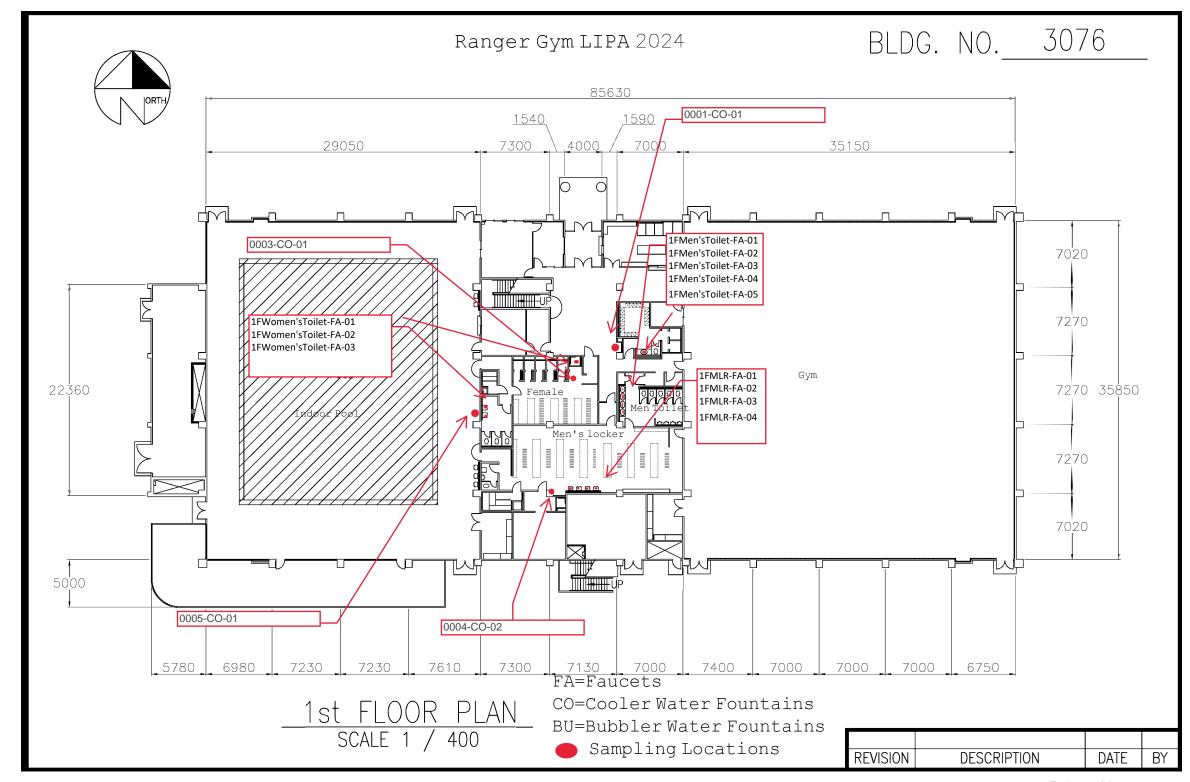
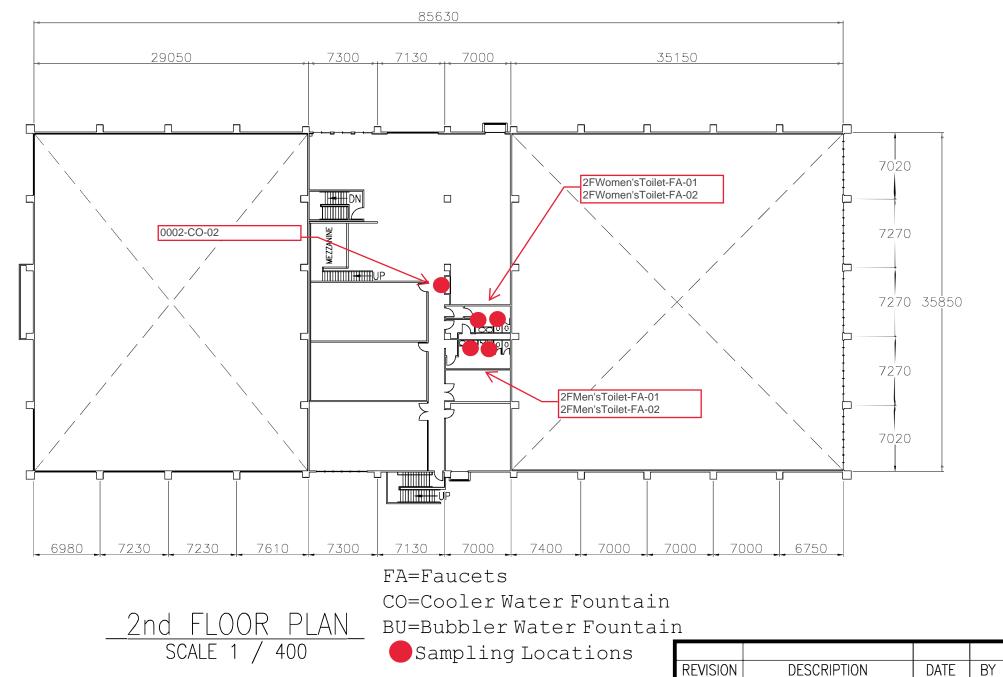
- 3. I have attached the details of the corrective measures and re-testing for the one outlet that initially exceed the screening level in enclosure (1). Full initial testing results are included in enclosure (2). Enclosure (3) shows the floor plans with identification makers for where the initial sampling was collected and the highlighted location of the exceedance.

- 2. We completed the corrective measures and flushing and additional testing shows that all outlets are now below the screening level of 10 ppb. Specifically, the corrective actions taken included cleaning and flushing the bubbler.
