Subj: IKEGO ELEMENTARY SCHOOL DRINKING WATER

Sample Summary Results Table
Priority Areas Lead Testing and Corrective Actions (October 2022)
FLEACT Yokosuka - Ikego Elementary School Building 824

Floor Plan - Ikego Elementary School (Building 824)

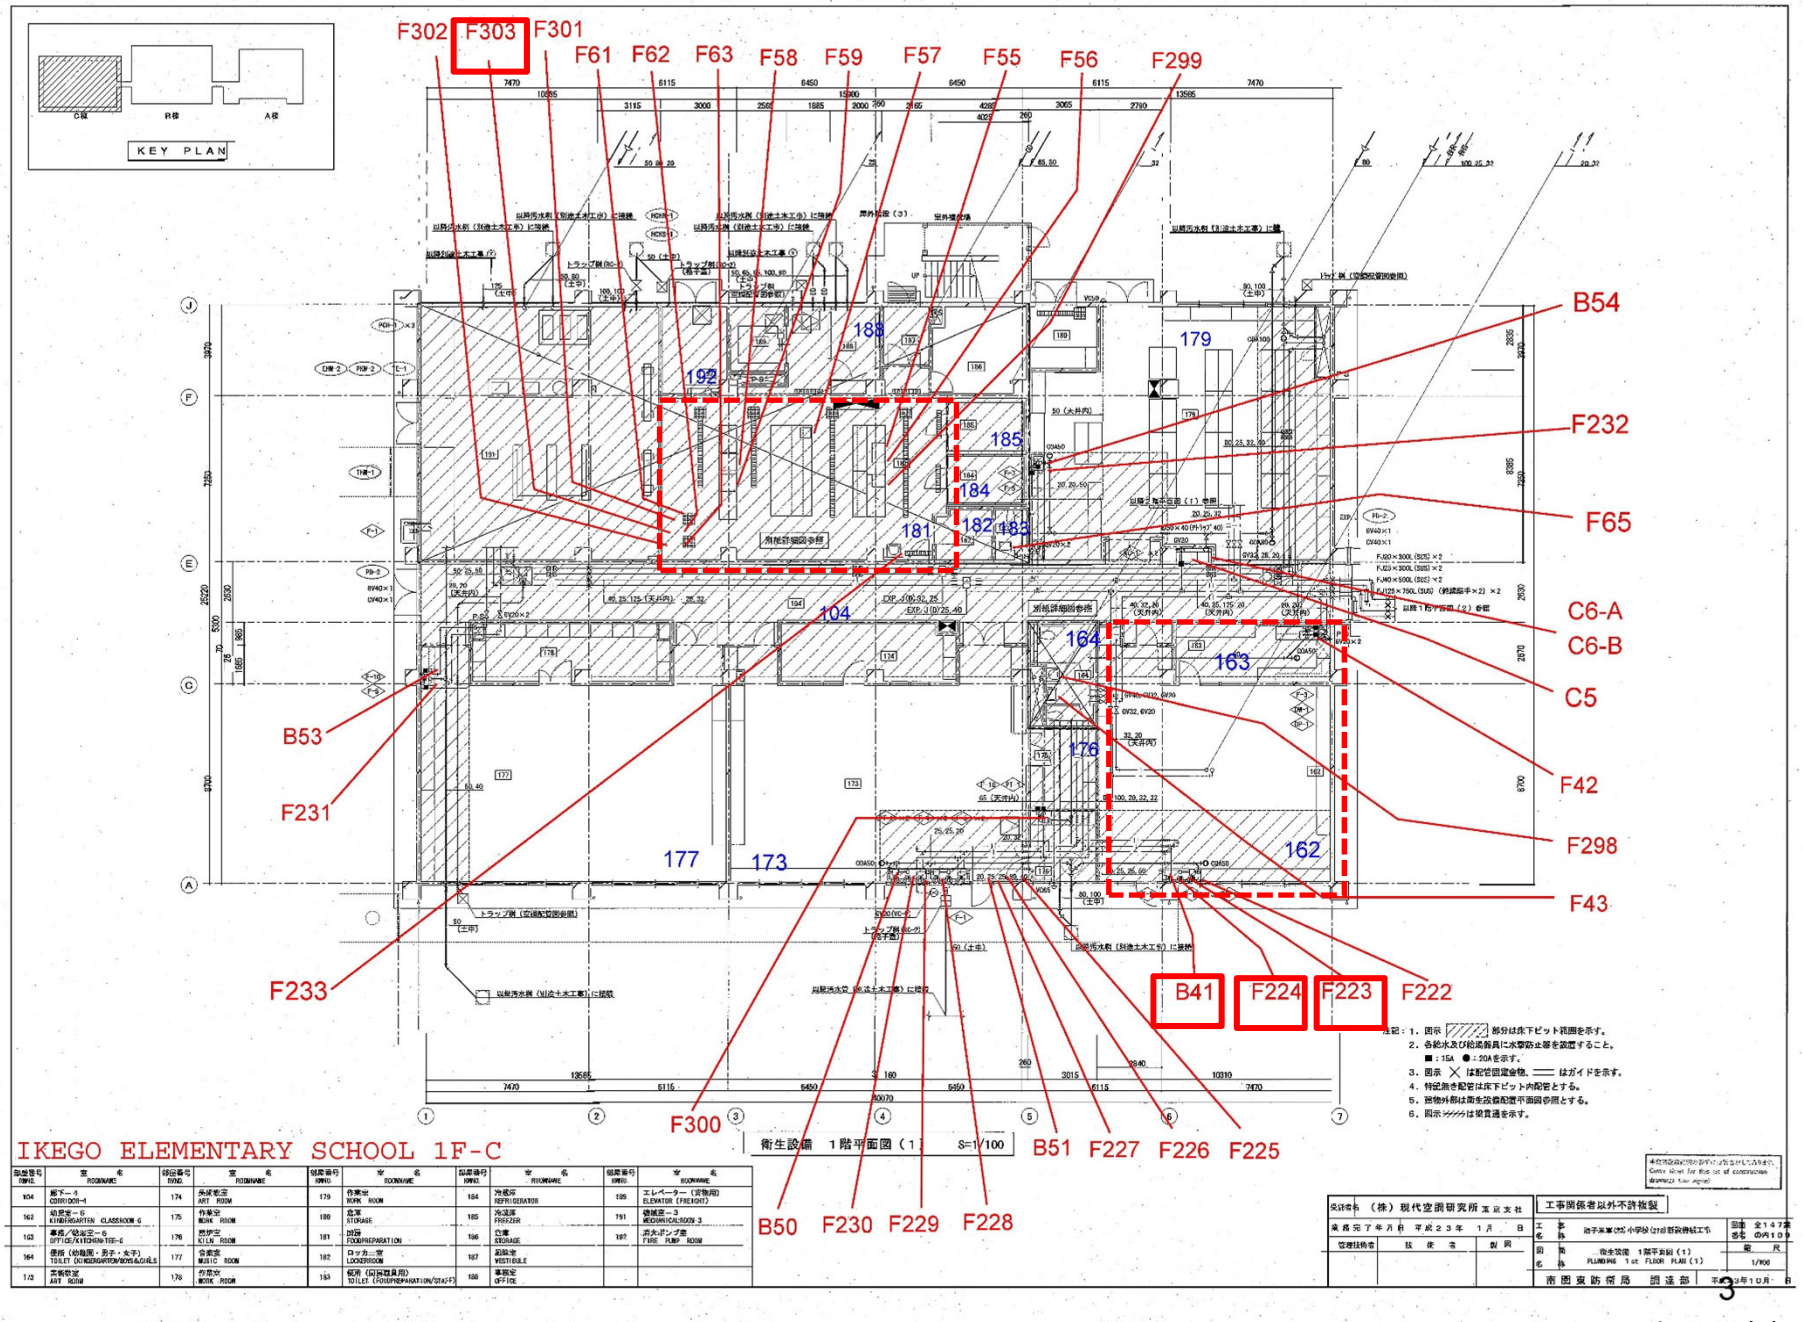
DRINKING	IKE824B041	162	Care Room	Bubbler	19	YES	6/16/2022	18	Non-Detect	Outlet and supply piping components were replaced with Lead free material.	1.1	Non-Detect
DRINKING	IKE824B044	165	Classroom 1	Bubbler	Non-Detect	NO	N/A	N/A	N/A	N/A	N/A	N/A
DRINKING	IKE824B045	166	Classroom 2	Bubbler	Non-Detect	NO	N/A	N/A	N/A	N/A	N/A	N/A
DRINKING	IKE824B046	167	Classroom 3	Bubbler	0.7	NO	N/A	N/A	N/A	N/A	N/A	N/A
DRINKING	IKE824B047	168	Classroom 4	Bubbler	Non-Detect	NO	N/A	N/A	N/A	N/A	N/A	N/A
DRINKING	IKE824B048	169	Classroom 5	Bubbler	2.7	NO	N/A	N/A	N/A	N/A	N/A	N/A
DRINKING	IKE824B049	171	Classroom 9	Bubbler	Non-Detect	NO	N/A	N/A	N/A	N/A	N/A	N/A
DRINKING	IKE824B050	173	Art room	Bubbler	Non-Detect	NO	N/A	N/A	N/A	N/A	N/A	N/A
DRINKING	IKE824B051	173	Art room	Bubbler	Non-Detect	NO	N/A	N/A	N/A	N/A	N/A	N/A
DRINKING	IKE824B053	177	Music room	Bubbler	Non-Detect	NO	N/A	N/A	N/A	N/A	N/A	N/A
DRINKING	IKE824B054	179	Work room	Bubbler	Non-Detect	NO	N/A	N/A	N/A	N/A	N/A	N/A

WASHING	IKE824F224	162	Care Room	MSF	48	YES	6/16/2022	19	2	Outlet and supply piping components were replaced with Lead free material. .	2.8	Non-Detect
WASHING	IKE824F043	164	Boys Girls Juvenility Bathroom	MSF	3	NO	N/A	N/A	N/A	N/A	N/A	N/A
WASHING	IKE824F298	164	Boys Girls Juvenility Bathroom	MSF	4.9	NO	N/A	N/A	N/A	N/A	N/A	N/A
WASHING	IKE824F217	165	Classroom 1	MSF	3	NO	N/A	N/A	N/A	N/A	N/A	N/A
WASHING	IKE824F218	166	Classroom 2	MSF	0.57	NO	N/A	N/A	N/A	N/A	N/A	N/A
WASHING	IKE824F297	167	Classroom 3	MSF	0.83	NO	N/A	N/A	N/A	N/A	N/A	N/A

d. In room 162, new certified lead-free motion sensor faucets, bubbler water fountains, supply piping, and supply valves were installed. In room 225, certified lead-free faucet and piping components were installed. After corrective measures were taken, water sampling confirmed the water from these sources is now below 15 ppb.

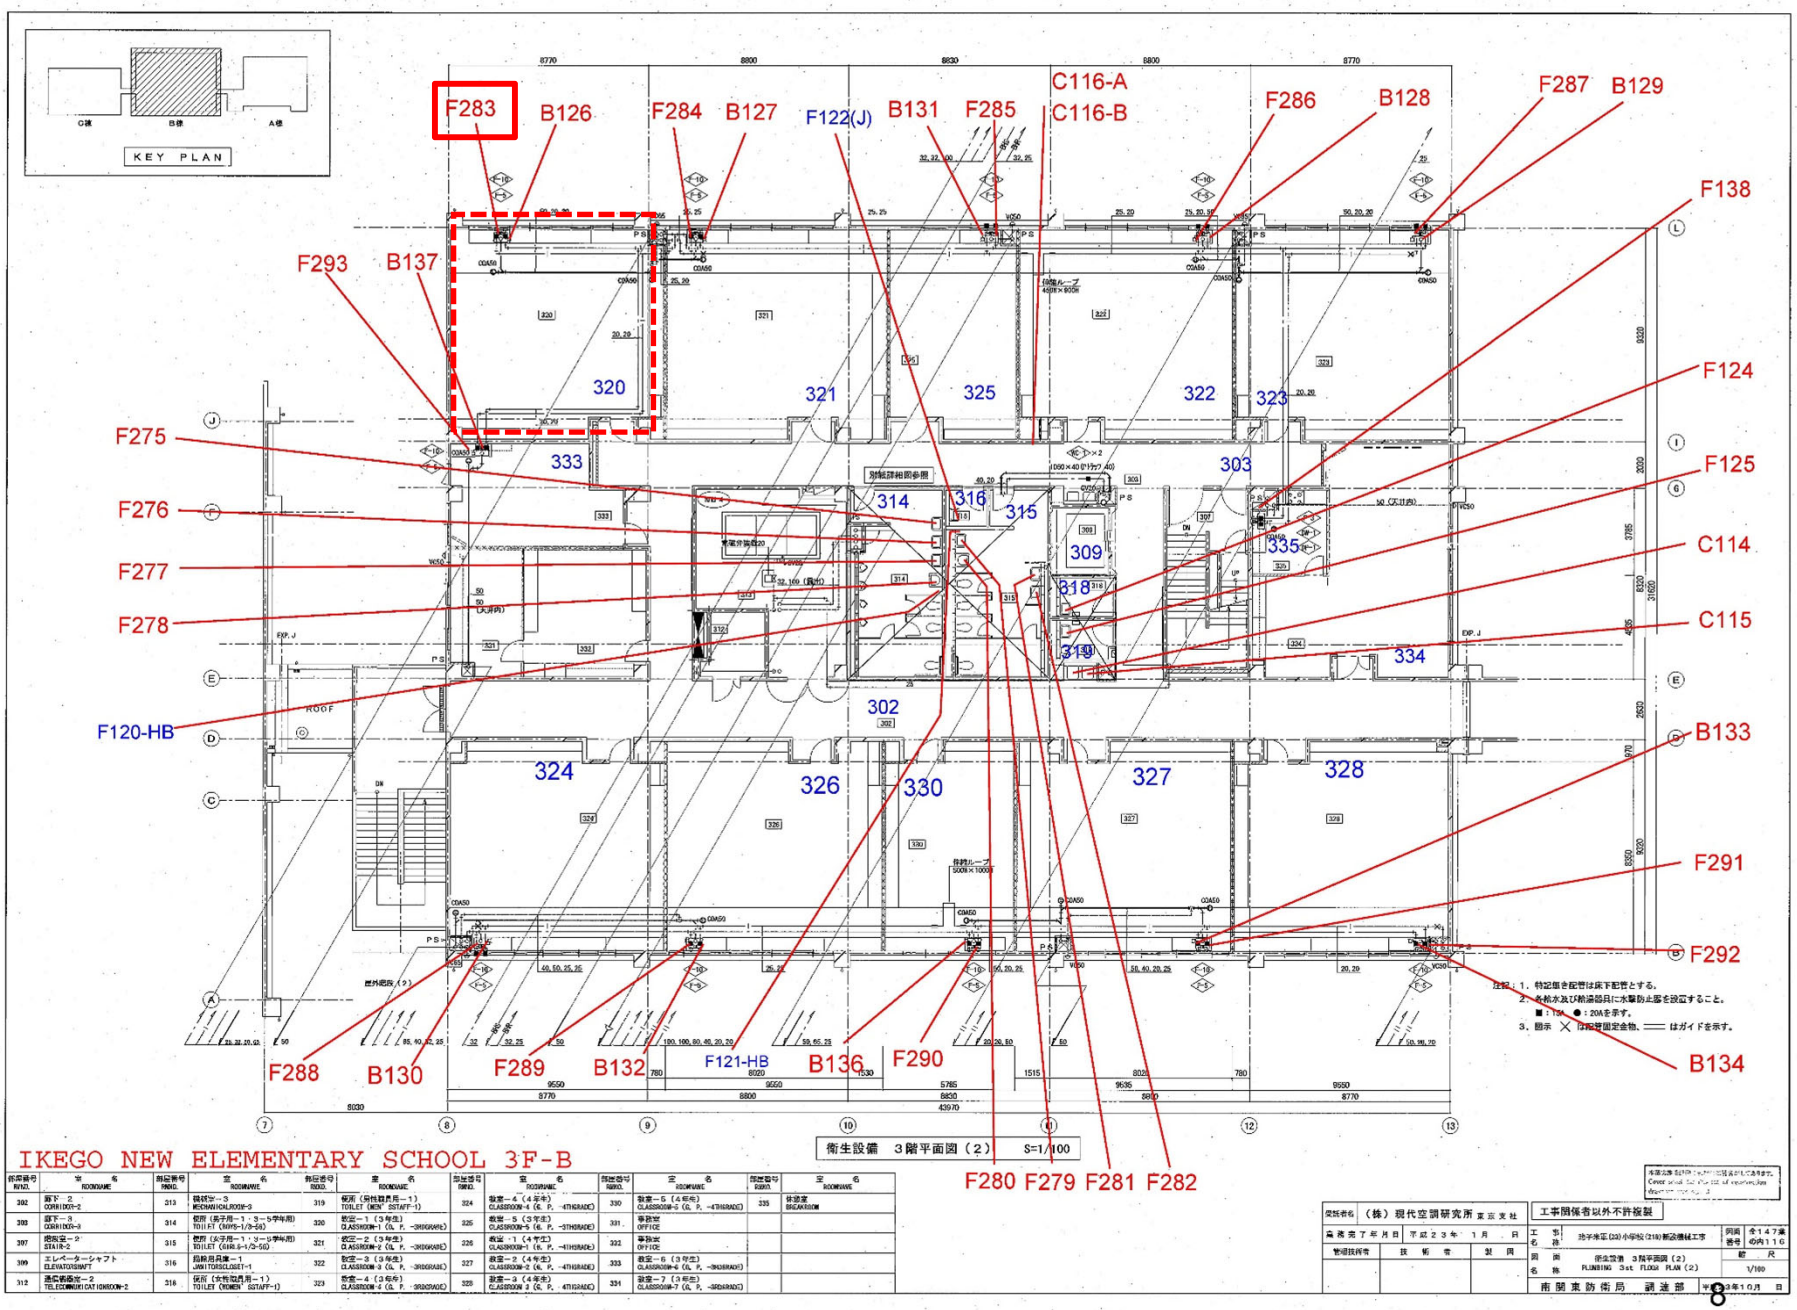
c. In room 320, follow-up test results for a motion sensor faucet initially tested at 15 ppb provided confirmation that the sink exceeded the 15 ppb. A certified lead-free faucet, supply piping, and supply valves to the sink were replaced and installed. After corrective measures were taken, water sampling confirmed that water from the sink is now below 15 ppb.

WASHING	IKE824F268	311	Girls Bathroom	MSF	1	NO	N/A	N/A	N/A	N/A	N/A	N/A
WASHING	IKE824F269	311	Girls Bathroom	MSF	4.1	NO	N/A	N/A	N/A	N/A	N/A	N/A
WASHING	IKE824F275	314	Boys Bathroom	MSF	0.56	NO	N/A	N/A	N/A	N/A	N/A	N/A
WASHING	IKE824F276	314	Boys Bathroom	MSF	1.1	NO	N/A	N/A	N/A	N/A	N/A	N/A
WASHING	IKE824F277	314	Boys Bathroom	MSF	0.79	NO	N/A	N/A	N/A	N/A	N/A	N/A
WASHING	IKE824F278	314	Boys Bathroom	MSF	Non-Detect	NO	N/A	N/A	N/A	N/A	N/A	N/A
WASHING	IKE824F279	315	Girls Bathroom	MSF	0.85	NO	N/A	N/A	N/A	N/A	N/A	N/A
WASHING	IKE824F280	315	Girls Bathroom	MSF	0.58	NO	N/A	N/A	N/A	N/A	N/A	N/A
WASHING	IKE824F281	315	Girls Bathroom	MSF	1.1	NO	N/A	N/A	N/A	N/A	N/A	N/A
WASHING	IKE824F282	315	Girls Bathroom	MSF	0.74	NO	N/A	N/A	N/A	N/A	N/A	N/A
WASHING	IKE824F124	318	Female Bathroom	MSF	0.71	NO	N/A	N/A	N/A	N/A	N/A	N/A
WASHING	IKE824F125	319	Male Bathroom	MSF	1	NO	N/A	N/A	N/A	N/A	N/A	N/A
WASHING	IKE824F283	320	Classroom 1	MSF	15	NO	6/16/2022	17	1.2	Outlet and supply piping components were replaced with Lead free material.	1.7	0.5
