DEPARTMENT OF THE NAVY
COMMANDER FLEET ACTIVITIES
SASEBO, JAPAN
PSC 476 BOX 1
FPO AP 96322-0001

SUBJECT: DRINKING WATER AT DARBY ELEMENTARY SCHOOL

Table 1. Summary of Results — Derby Elementary - Hario

2nd FLOOR PLAN: BLDG.#5114

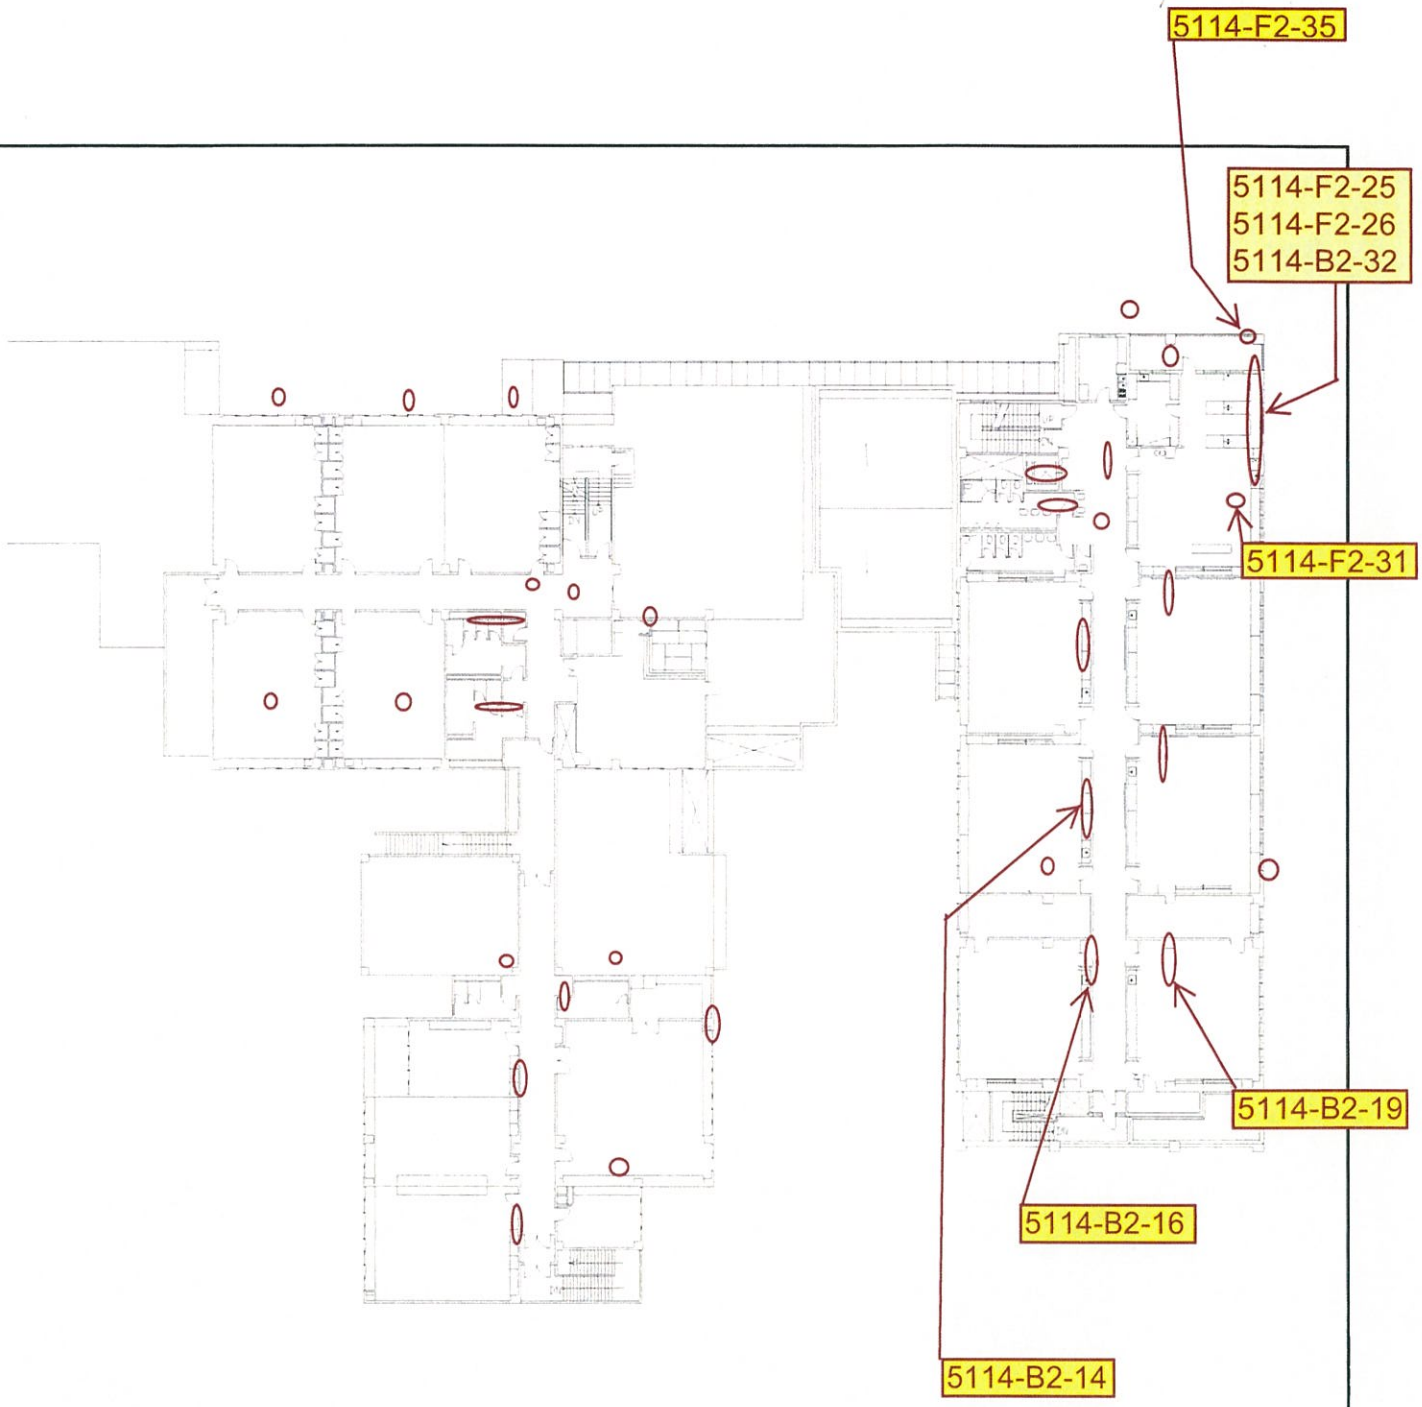
The lead levels were higher than the EPA-recommended screening level at four classroom bubblers in Rooms 257, 258, 259 and 262, and four classroom faucets in Room 262 (Science Lab). After receiving the test results, we immediately took these water sources out of service. None of the hallway drinking fountains at the school exceeded the screening level. Details on the corrective actions we will take to reduce the amount of lead in water at these fixtures will be discussed in an overview of results and actions to be provided upon completion. Enclosures (1) and (2) are Complete Test Results and a Floor Plan of the elementary school that indicates the location of the fixtures that had lead levels higher than the EPA-recommended screening level.

5114-B2-14 Yellow Boxes indicate location and ID number of fixtures requiring additional corrective actions
